PHASE 1 BLACK POST-FIRE BAER SOIL BURN SEVERITY MAP RELEASED

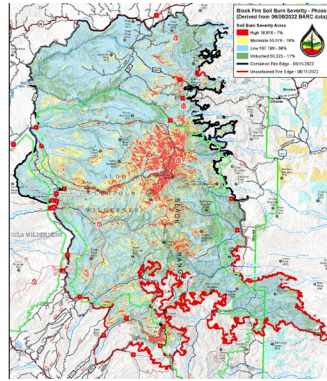
BAER team specialists completed its field data gathering for Phase 1 of the Black burned area on June 12, 2022. The team's post-fire soil burn severity (SBS) map analyzes 289,973 acres of the *Caballo, Mimbres, and Upper Gila*, watersheds. The map and the data display soil burn severity (SBS) categories of unburned/very low, low, moderate and high.

Approximately 75% of the Phase 1 acres are either unburned/very low or low SBS, while 18% are moderate SBS and 7% are high SBS. Any additional acres that are burned by the Black Fire will be assessed and analyzed in a Phase 2 post-fire BAER assessment.

The BAER team will use the Phase 1 SBS data to analyze and model post-fire hydrologic response for each of the watershed to determine if there are any threats or risks to NFS BAER critical values. The team shares its analysis with cooperating agencies who have the authority to work with private property owners downstream from the burned area that potentially may have post-fire threats from increased water and debris flows. The BAER team's Phase 1 assessment and findings will be documented in a report that will be posted to the team's InciWeb page after the report has been reviewed and approved by the Gila NF and Regional Office line officers.
